FINAL REPORT

**North Carolina Department of Transportation
Research Project No. 2011-06**

Durability of Lightweight Concrete Bridge Decks – Field Evaluation

February 15, 2013

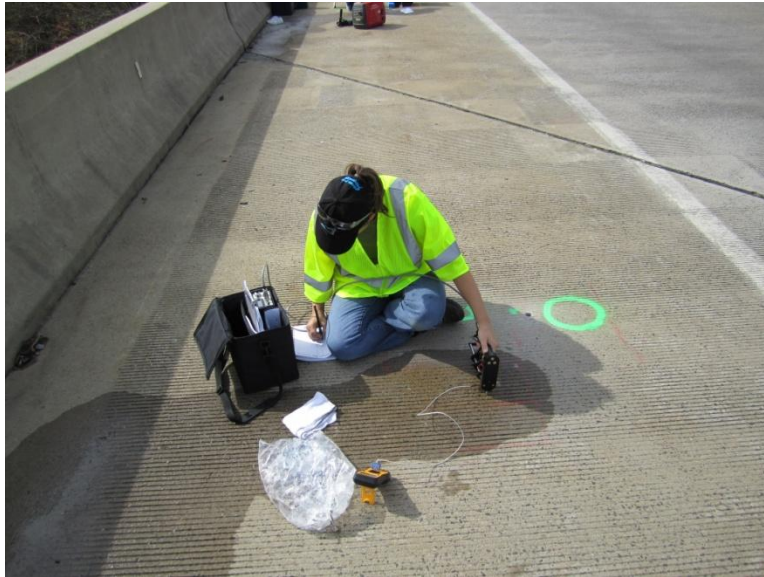
Once the minimum two-hour conditioning time had elapsed, the bag of ice and wet towel was removed from the test location. Excess water was removed from the surface of the saturated test location using a synthetic bristle brush. A minimum of eight readings were taken at each test location, with readings spaced approximately one in apart. For this work, the four adjustable probes were each spaced 2 in (5.08 cm) apart. A temperature measurement of the concrete deck surface was taken within a few seconds of each surface resistivity measurement. Surface resistivity testing is shown in Figure 3-4, below.

Figure 3-4: Surface resistivity testing.

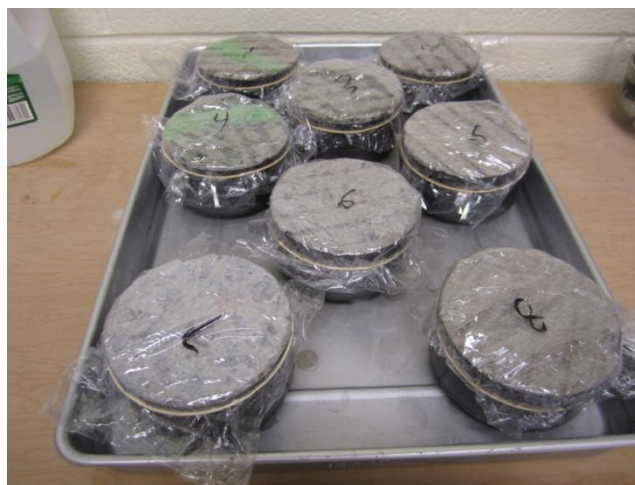
Each specimen was placed into approximately 0.040 in to 0.118 in (1 to 3 mm) of water, with the submerged test surface sitting on three spherical single-point supports. Specimens were weighed at immersion durations of 1 min, 5 min, 10 min, 20 min, 30 min, 60 min, 2 hr, 3 hr, 4 hr, 5 hr, 6 hr, 1 day, 2 days, 3 days, 4 days, 5 days, and 6 days. Measurements were taken at times that were within the tolerances specified in ASTM C1585. Prior to weighing each specimen at the prescribed time, the specimen was dabbed with a damp paper towel to remove excess distilled water. Each measurement did not take longer than 15 sec, and after weighing, each specimen was immediately replaced on the supports, with the bottom surface submerged in the distilled water. A photograph of specimens prepared for ASTM C1585 sorptivity testing is shown in Figure 3-7.

Figure 3-7: ASTM C1585 sorptivity testing.

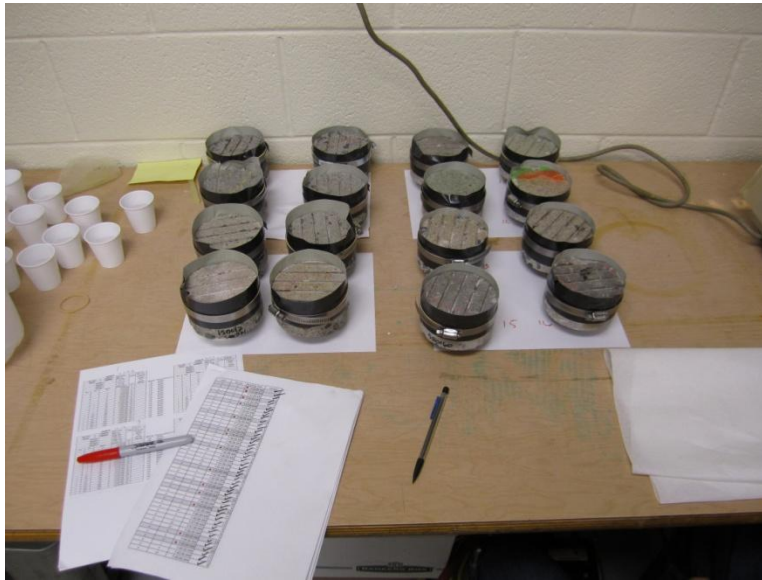
Prior to performing the ponding sorptivity testing, specimens were reconditioned in accordance with the same conditioning procedure utilized for the ASTM C1585 sorptivity test. For the ponding test, water resistant duct tape was applied to the circumferential sides of each specimen, with approximately 1 in of tape allowed to extend above the top surface of the specimen. A rubber band was placed around the tape at the top of the core, and a circular hose clamp was then tightened around the rubber band and tape. The rubber band facilitated even distribution of pressure from the hose clamp, creating a barrier for the distilled water added to the reservoir created by the duct tape extended above the top of the core. Specimens prepared for ponding sorptivity testing are shown in Figure 3-8.

Figure 3-8: Ponding sorptivity testing.

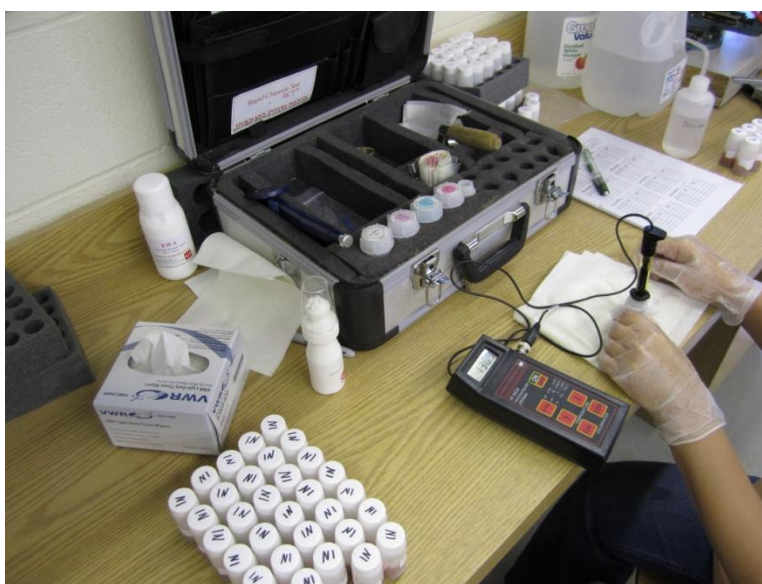
After electrode calibration was performed (once for each day's testing), concrete powder samples in the extraction liquid were tested. To perform each test, 0.053 oz (1.5 grams) of powder (measured within a tolerance of $\pm 2\%$) was weighed and put into the test vial with the proprietary extraction solution. The test vial was shaken for 5 min. After the vial was shaken for 5 min, the cap was loosened to allow gas to escape and then retightened. As prescribed by the manufacturer, test vials were allowed to sit overnight, allowing adequate contact time between the powder sample and the extraction liquid. The following morning, the electrode was submerged into each vial, the reading was allowed to stabilize, and the measurement was recorded. Between test vials, the electrode was cleaned using distilled water as prescribed by the equipment manufacturer. Using the calibration curve prepared for the day's testing, the mV readings for each vial were converted into chloride content (in percent). The RCT test setup is shown in Figure 3-9.

Figure 3-9: Rapid Chloride Test (RCT).

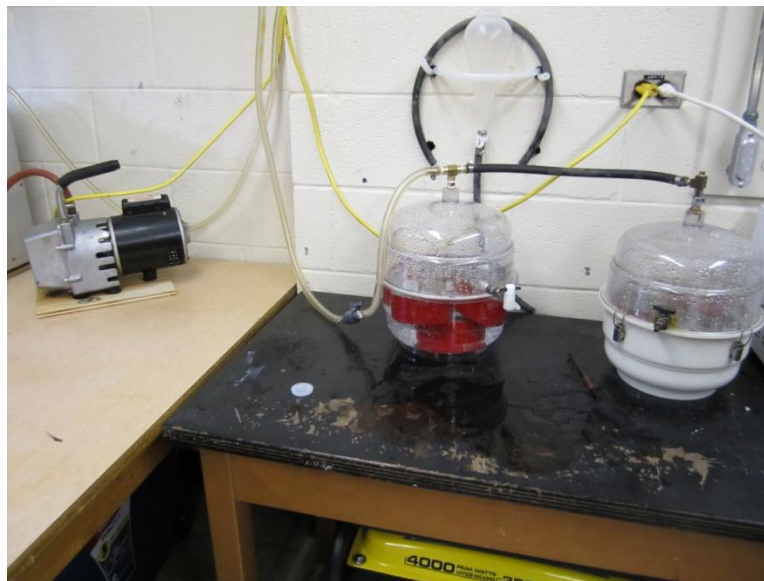
The circumferential sides of each specimen were coated in fast setting epoxy, which was allowed to cure overnight. Prior to testing for chloride ion permeability, test specimens were conditioned using the vacuum saturation procedure specified in ASTM C1202. The vacuum saturation apparatus is shown in Figure 3-10.

Figure 3-10: Vacuum saturation of rapid chloride permeability test specimens.

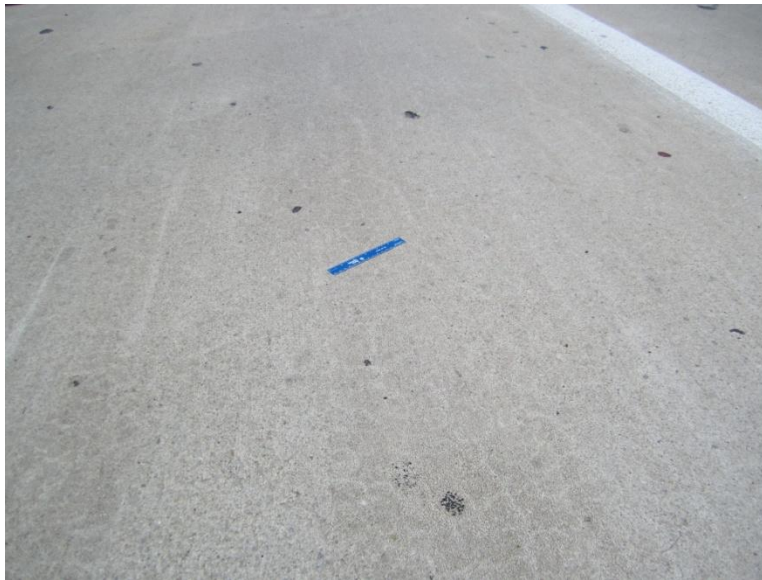
Pattern cracking denoted as low severity was typically only faintly visible during the observations, comprised of fine hairline cracks (as "hairline" is defined in ACI 201.1, "Guide for Conducting a Visual Inspection of Concrete in Service"). The cracks were usually networked to some extent, but often, areas of cracks were just beginning to network. Typical pattern cracking denoted as low severity is shown in Figure 4-1. Pattern cracking denoted as moderate severity was easily visible during the visual survey, and the widths of the cracks were larger than what would be considered hairline by ACI 201.1. Typical pattern cracking denoted as moderate severity is shown in Figure 4-2. No pattern cracking observed during this study was judged to be high severity cracking.

Figure 4-1: Typical pattern cracking denoted as low severity.

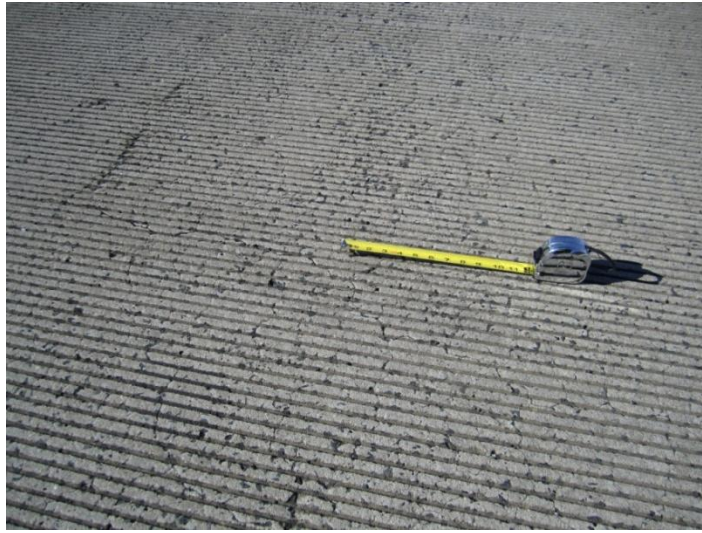
Figure 4-2: Typical pattern cracking denoted as moderate severity.

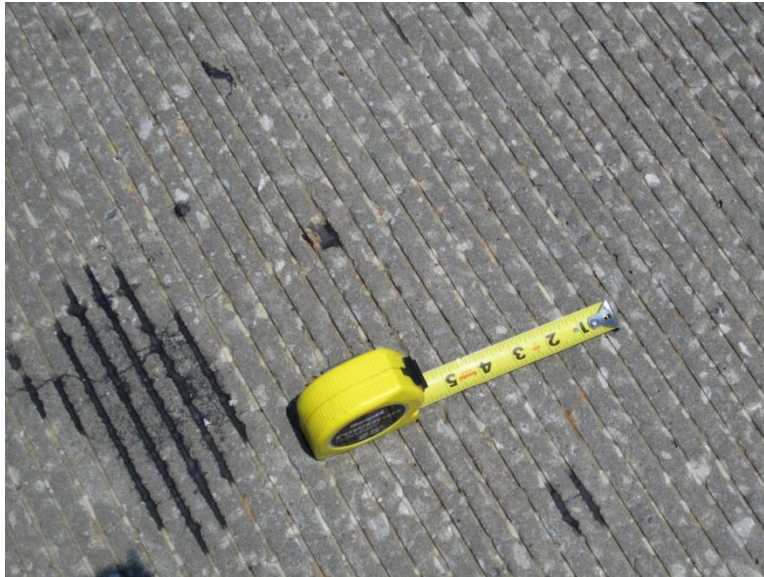
Longitudinal cracks that are not adjacent to expansion joints were also observed on several bridge decks, including bridge decks 5L, 7N, 8N, and 9N. A typical longitudinal crack is shown in Figure 4-5. Longitudinal cracks on bridge decks can be the result of a lever arm forming due to cantilever action from wheel loads applied to the deck alongside of girders. These could be result of overstress due to oversized loads, or some other overload issue related to detailing of reinforcement. Longitudinal cracks could also have resulted from vehicle impacts into barriers.

Figure 4-5: Typical longitudinal cracking on bridge deck 8N.

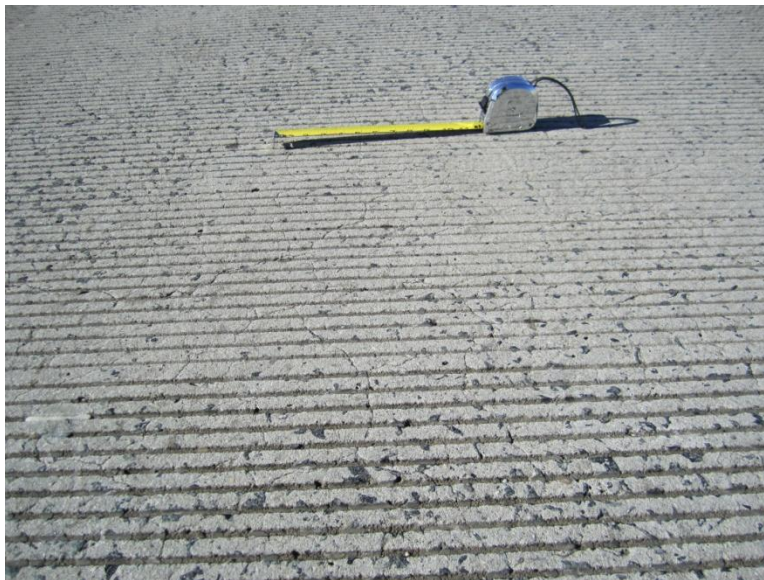
Pattern cracking was observed on a number of bridge decks included in the study. As discussed in the literature review presented in Section 2.1, pattern cracking can be attributed to a number of factors, both directly related and unrelated to concrete materials characteristics. The most severe pattern cracking was observed in bridge decks 6N and 6L. These bridge decks, located on I-40 westbound in Winston-Salem, North Carolina, had the highest traffic loading (ADT of 68,000 and 64,000, respectively). This pattern cracking could have initiated due to materials related issues, but may also have been exacerbated due to traffic loads. Typical moderate severity pattern cracking on bridge deck 6N is shown in Figure 4-6.

Figure 4-6: Typical moderate severity pattern cracking on bridge deck 6N.

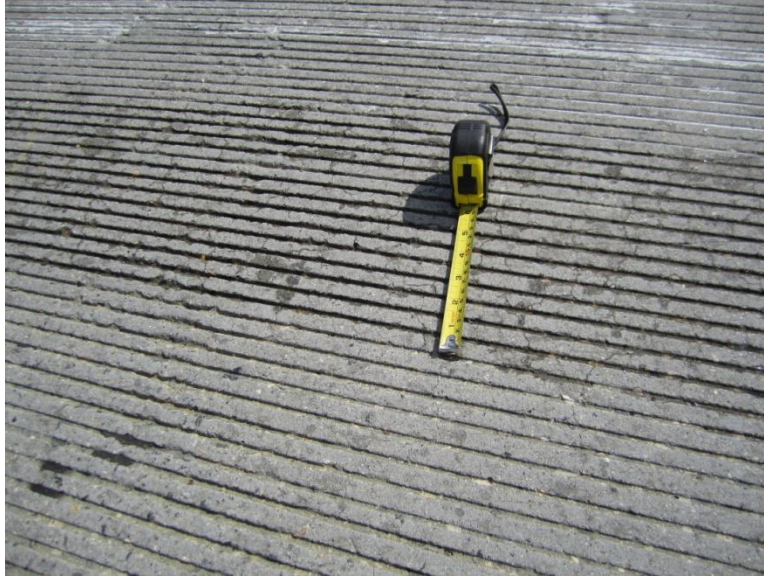
Figure 4-7: Typical low severity pattern cracking on bridge deck 1N.

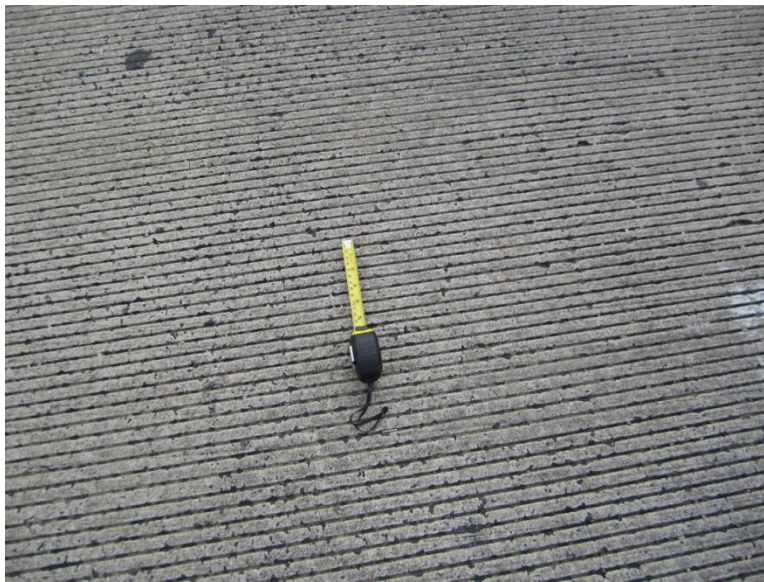
oriented in the longitudinal direction (shown in Figure 4-8). The cause of these cracks is not readily evident at this time.

Figure 4-8: Typical relatively short longitudinal crack on bridge deck 5L.

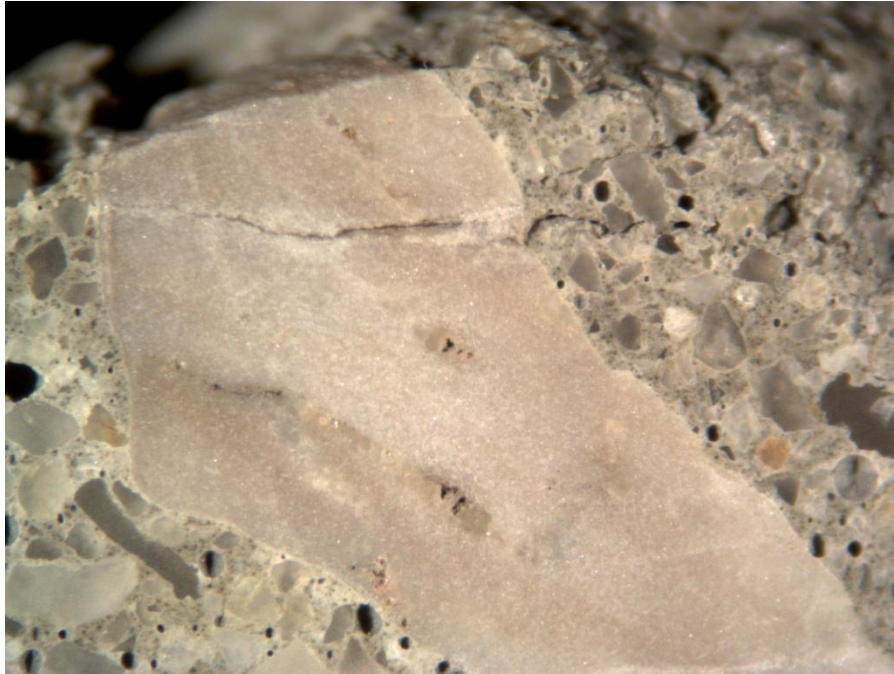
Figure I-37: Photomicrograph of polished surface prepared from bridge deck 8N, core C-7, taken at a magnification of 15x. Macrocrack extending from top surface through coarse aggregate.
